# Bickenhall Mansions Management Ltd

## Welcome

## Brief for the Refurbishment Project

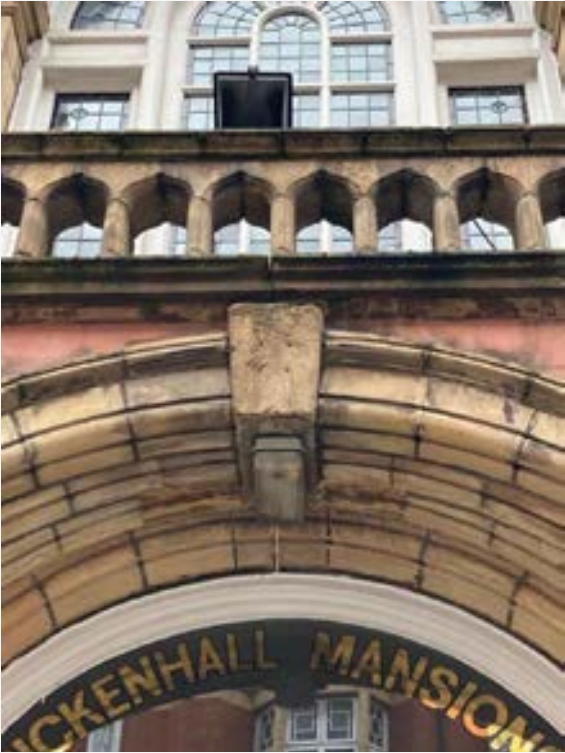
Damaged and stained entrance features

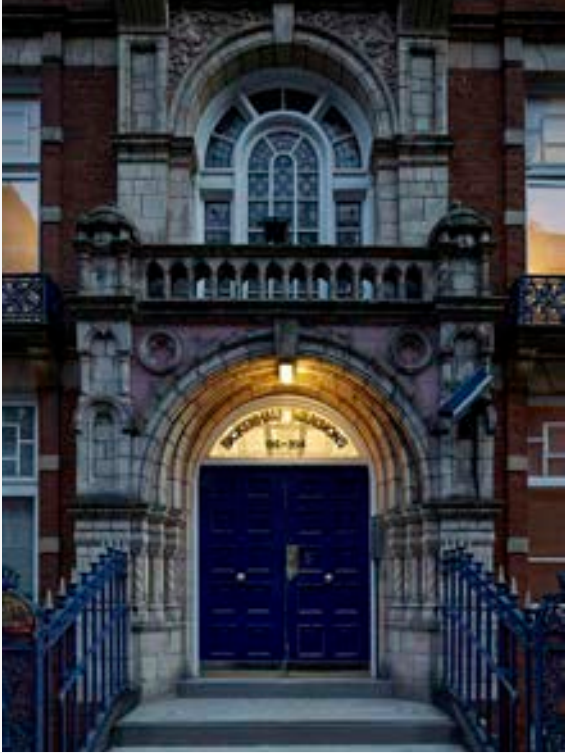
Poor lighting | Low quality light fittings | Broken fixture at 1st floor

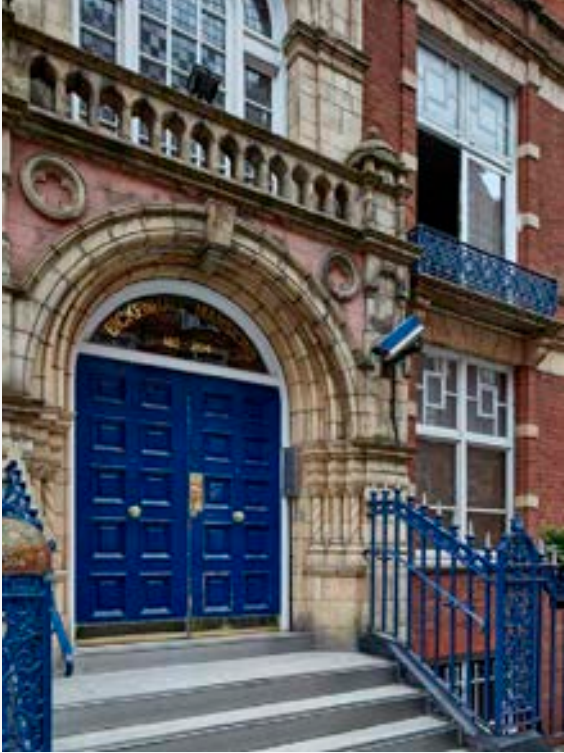
Low quality floor finishes | Exposed cabling and wiring | Oversized CCTV | Stained masonry and terracotta

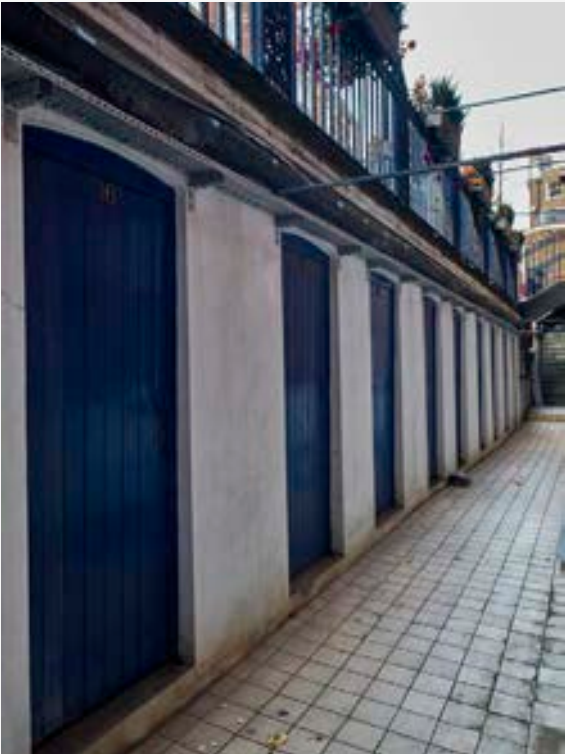
Redundant wiring | Broken floor tiles | Stained paintwork | Vault doors water damaged

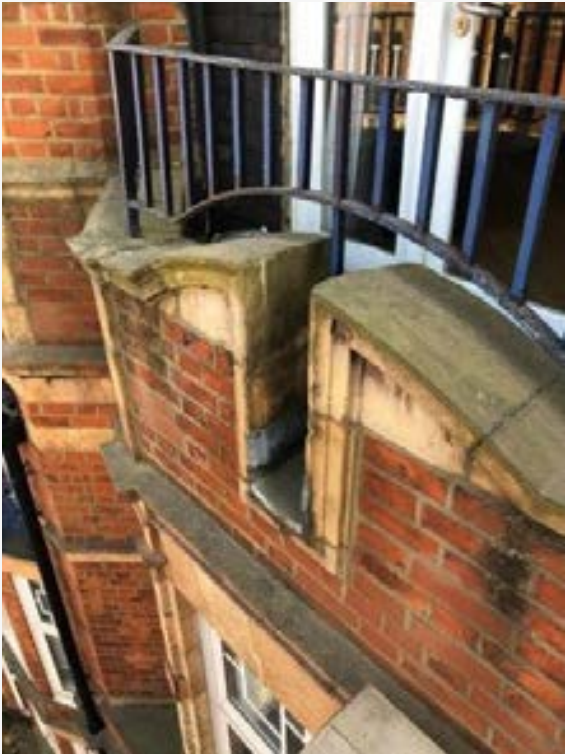
Stained and damaged details to facade | Multiple layers of peeling paintwork to railings

- Entirely stripped back railings to allow easier paint application over the coming years
- Removed damaged pigeon netting to prevent further build-up of trapped debris

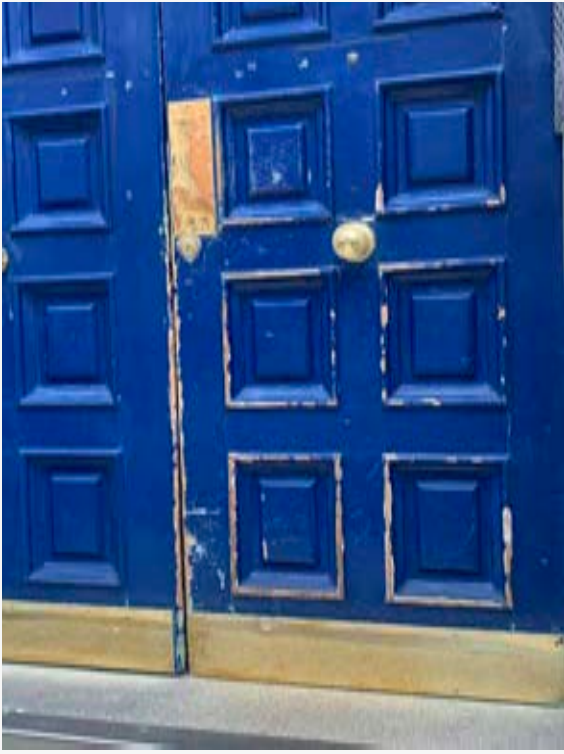
Continuously chipped paint finish to doors

- Installed solid entrance doors in lieu of painted which were continuously chipped. Automatic opening mechanism should reduce damages to finishes further. Omitted noisy opening/closing buzzer and door slam which was intrusive to adjoining flats
- Removed applied paint to the west façade leaving a low maintenance self-finish brick
- Removed known redundant items (cabling, boxing etc) to simplify future management
- Replaced missing/damaged rainwater goods and tiles, resized inadequate hoppers, renewed leadwork to roofs, removed weed growth and installed new flashings to reduce leaks
- Replaced corroded steels above windows heads to prevent further damage to terracotta, replaced failing brickwork, repointed throughout to maintain integrity of the fabric

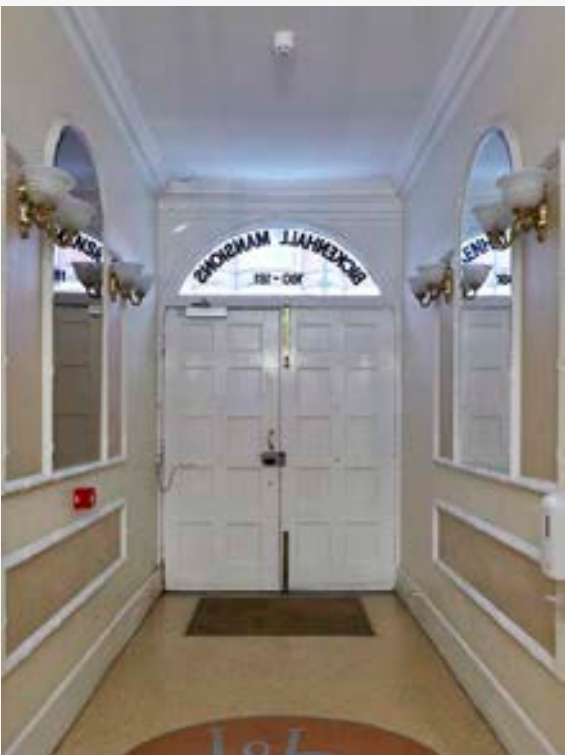
Heavy and loud doors | Tired and dated interiors | Insufficient matting to remove dirt - slip hazard when cleaning floor

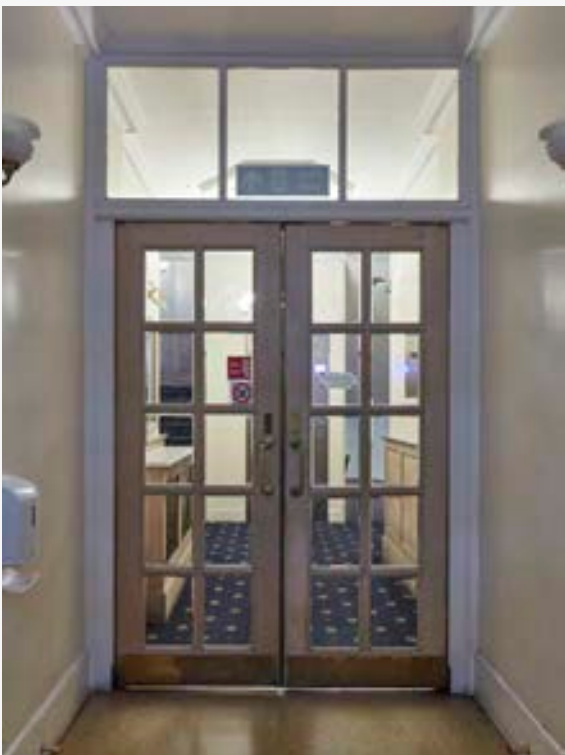
Tired and dated interiors | Poor quality signage | Mismatched timber finishes

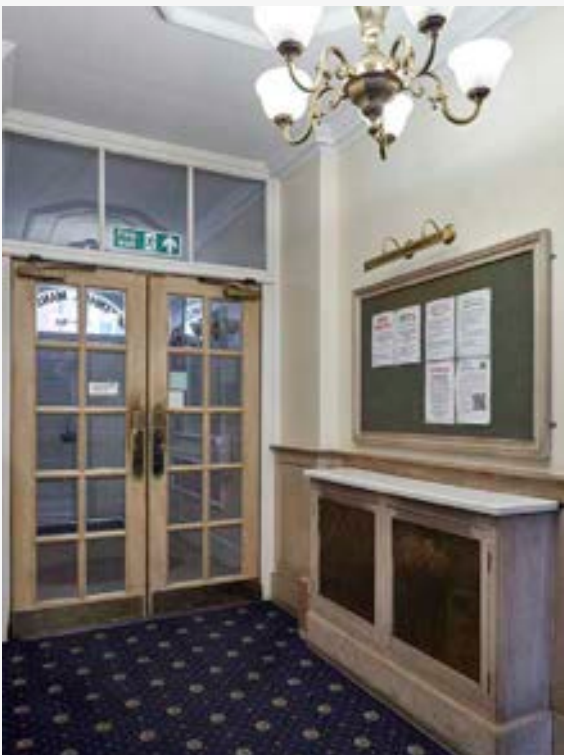
Dirt stained and bulky radiator casings | Untidy appearance from clutter and poor signage | Inefficient bulbs (previous frequently blown)

- Installed TV screen centrally linked to Building Manager allowing information to be shared quickly and easily across the estate
- Removed radiator covers that were energy inefficient and confined circulation space

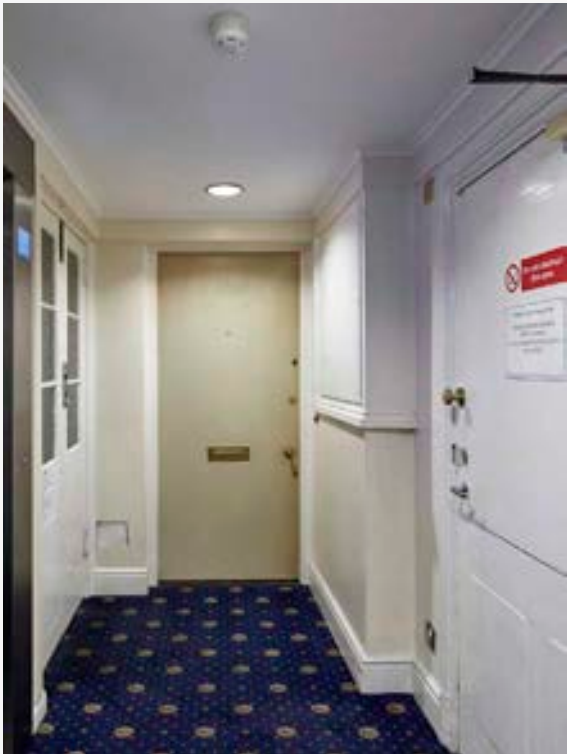
Inconsistent finishes and fittings throughout

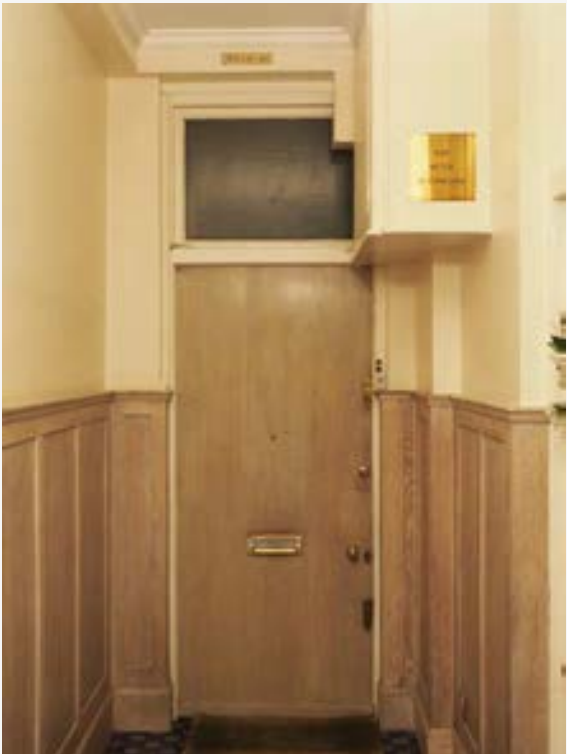
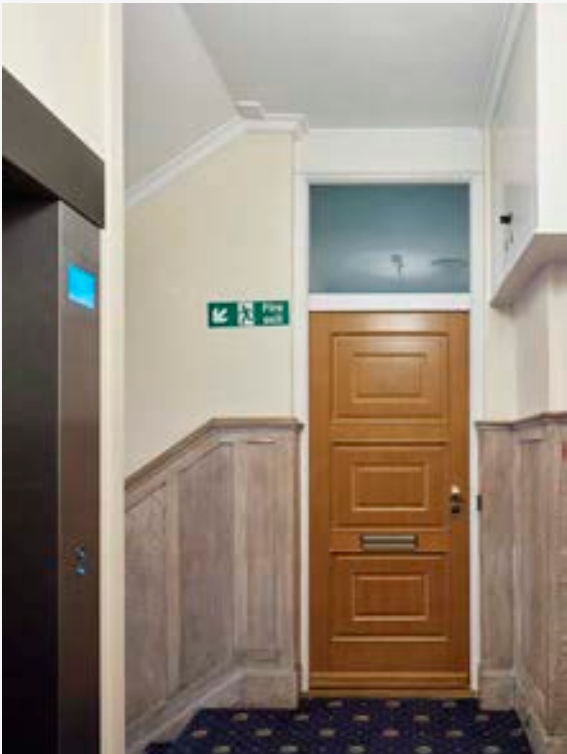
Varying door types and finishes

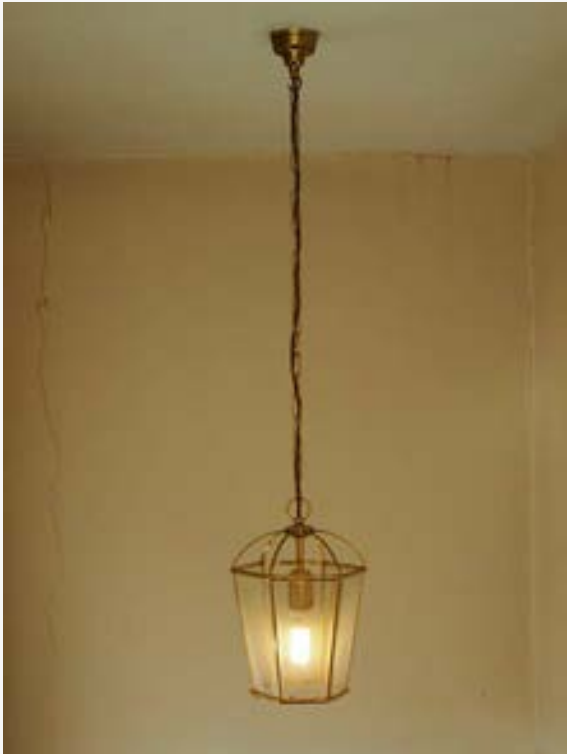
Poor lighting levels | No lighting control and energy inefficient fittings

- Adopted a more energy efficient lighting strategy; PIR sensors so that lights come on/off as people move through the common parts, LED light bulbs that have a far greater life span and reduced number of fittings to ease maintenance.

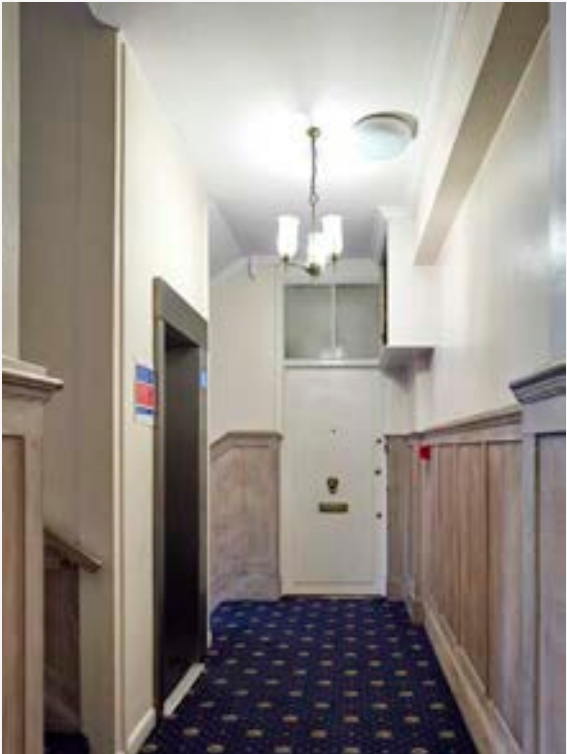
Dated and tired appearance | Inconsistent finishes and fittings throughout | Bulky high level cabinets

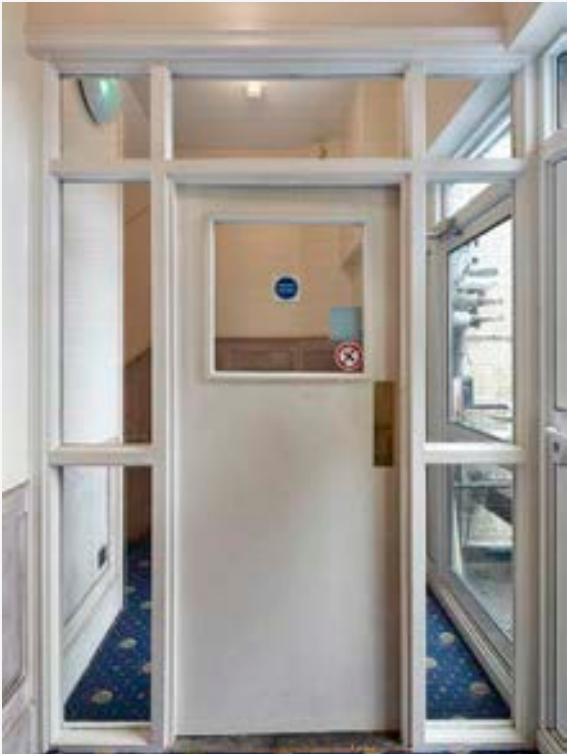
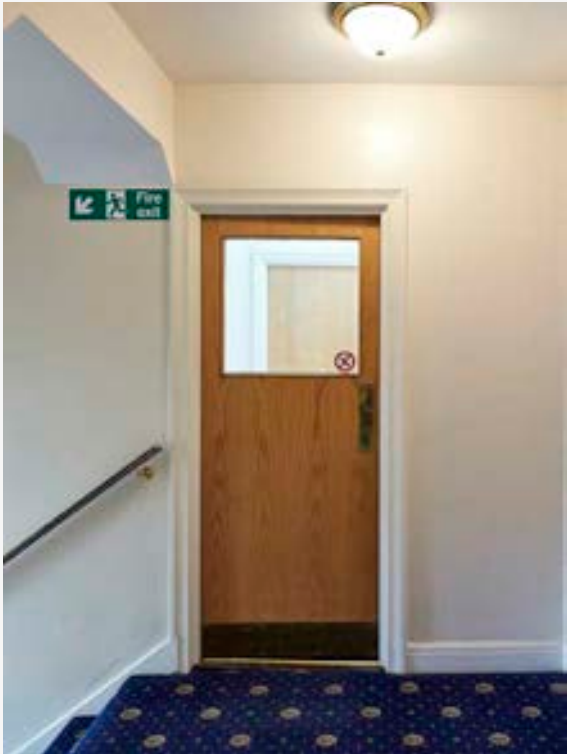
Fire doors with excessive gaps and of poor appearance and inconsistent finish throughout

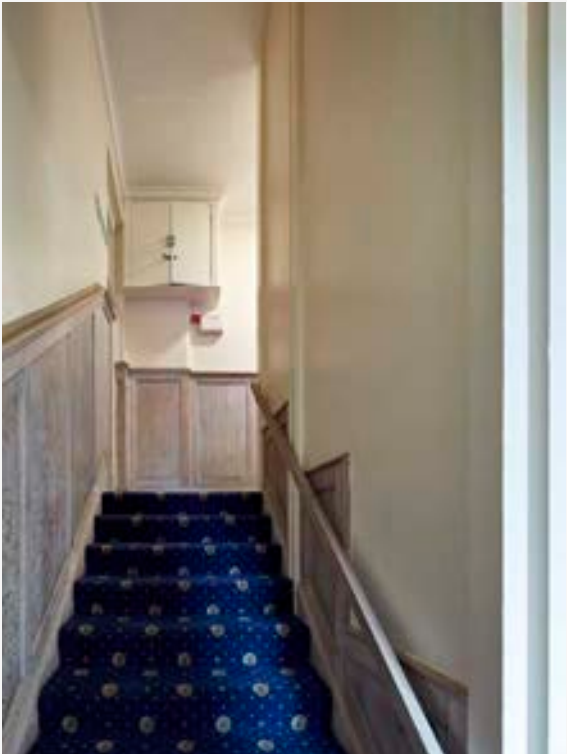
Poor quality and badly sited cabinets

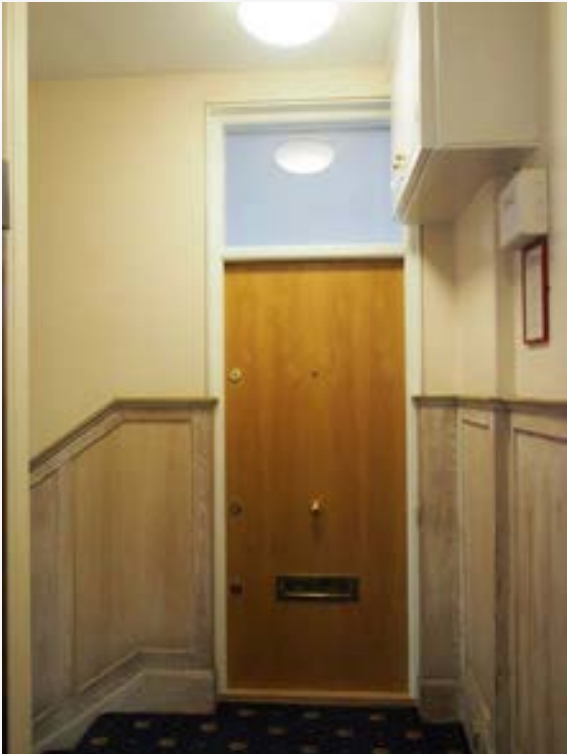
Fire rating of doors unverified and without self closers | Inconsistent appearance

- All flats have installed new fire-certified apartments doors that maintain the integrity of the fire strategy for the entire block
- Panelling in communal parts now has a class O fire rated finish
- Smoke vents on the 6th floor open automatically to rapidly release any smoke in the stair well in the event of fire
- New fire alarm system installed throughout the communal parts with a fire alarm sounder installed within each flat
- Lightning cable renewed and replaced.

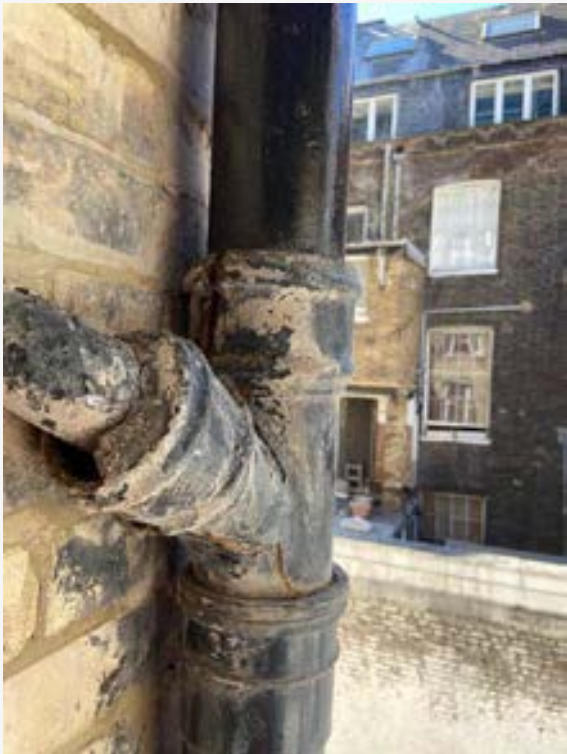
Corroded rainwater goods

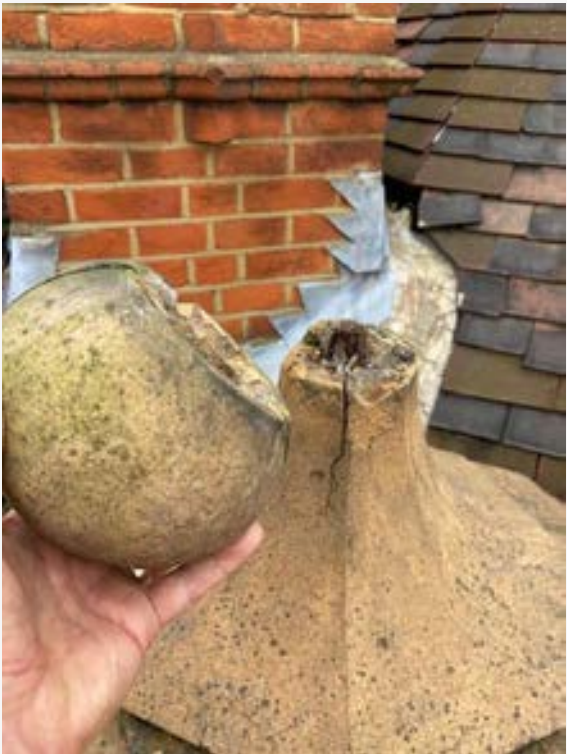
Loose and damaged building fabric

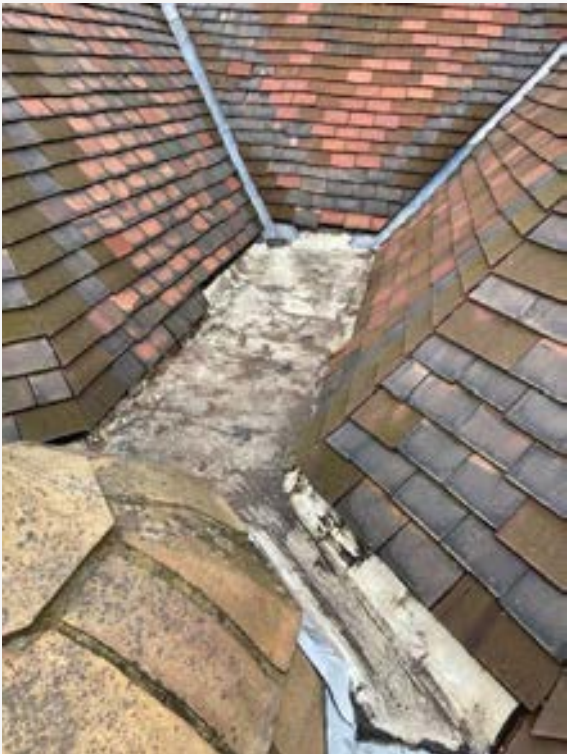
Damaged roof coverings and guttering

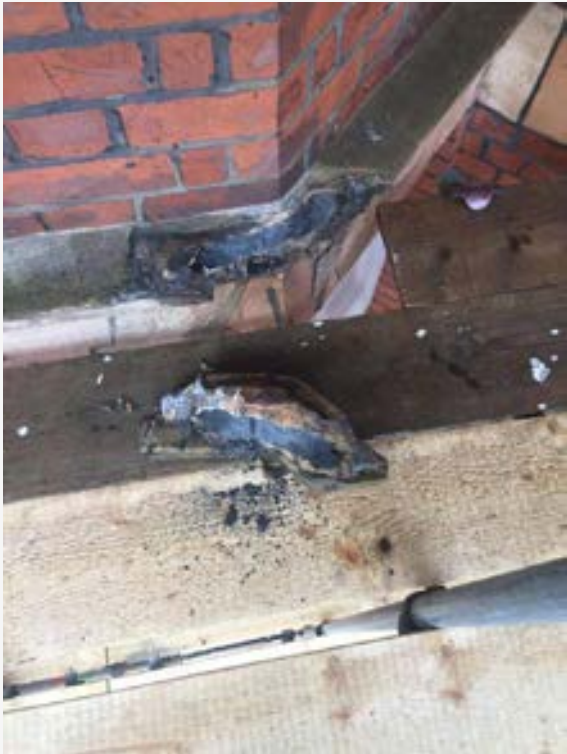
Loose and crumbling masonry

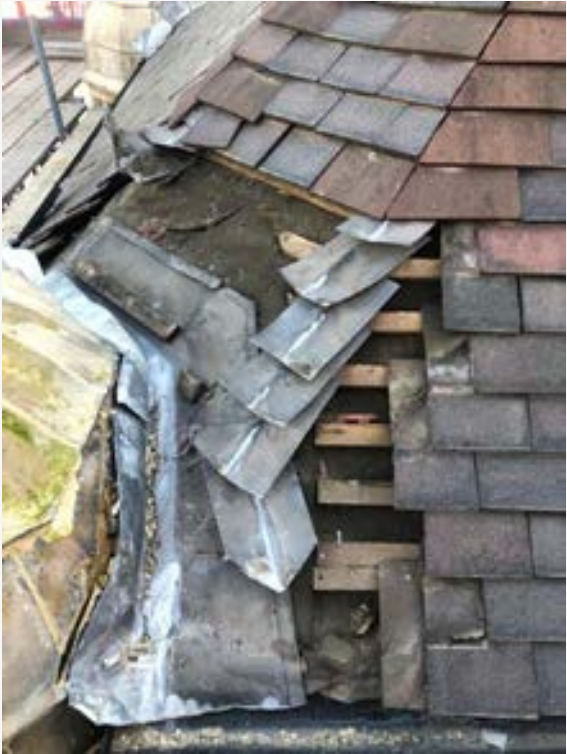
Damaged roof coverings and guttering | Loose and missing roof tiles

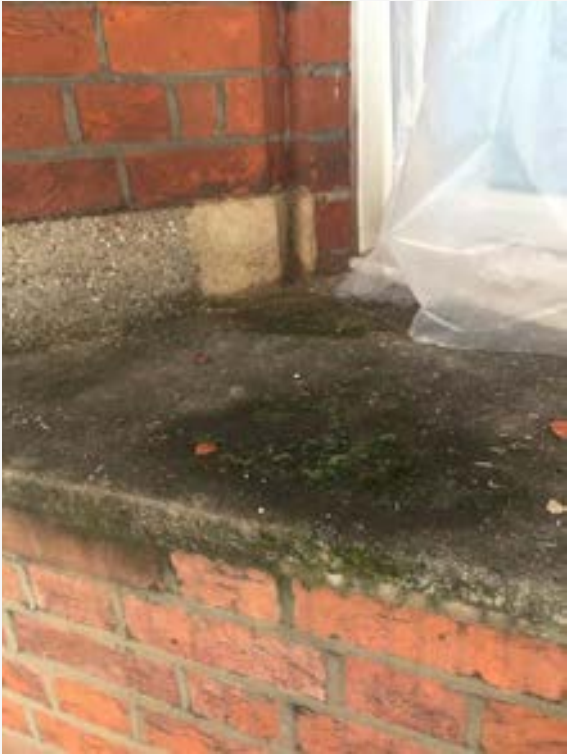
Water damage to window sills

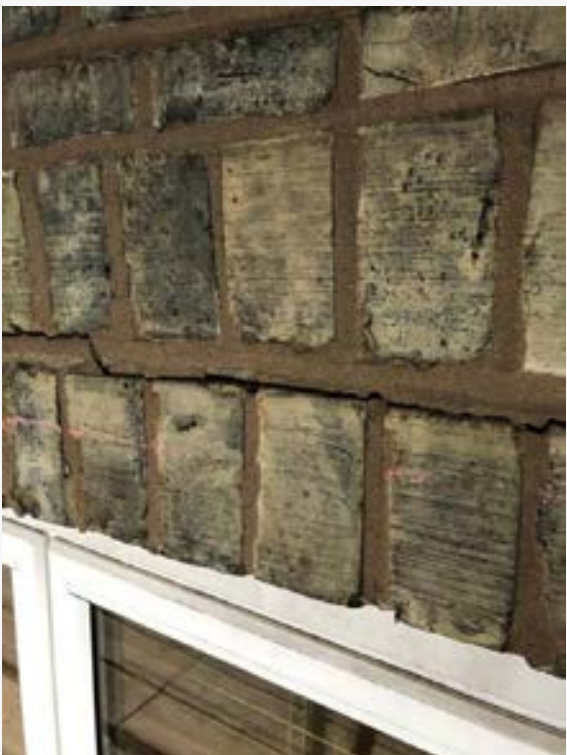
Poor brickwork repairs and previous re-pointing

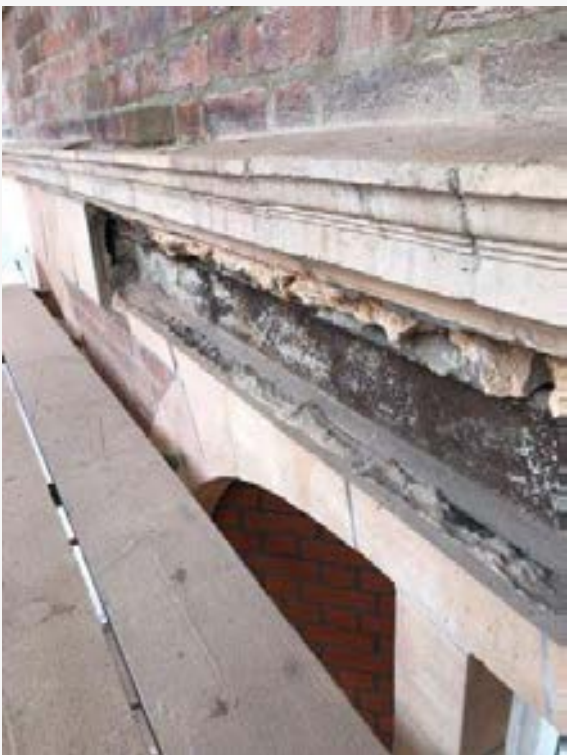
External works to block 7 informed us of the unknowns that the Board were cautious about, namely corroding steelwork at high level behind the terracotta on the main facade. We can reasonably anticipate that we will meet the same conditions on all other blocks.

Rusting steels damaging terracotta

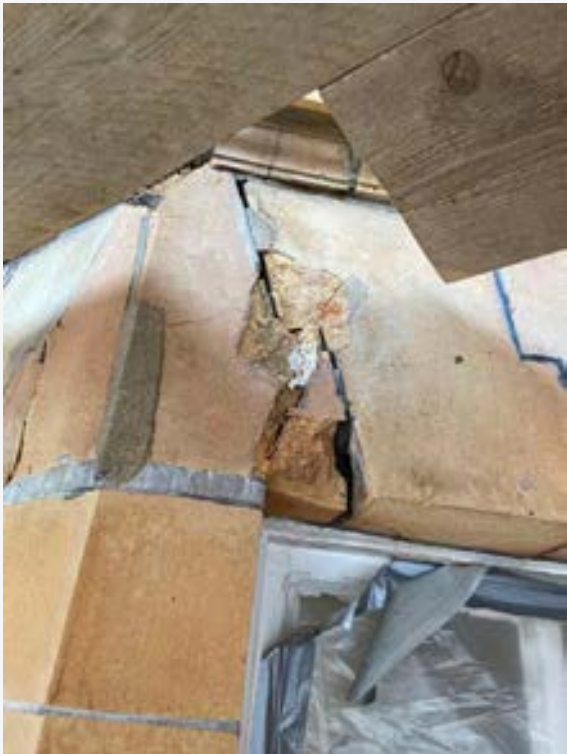
Cracked and damaged masonry

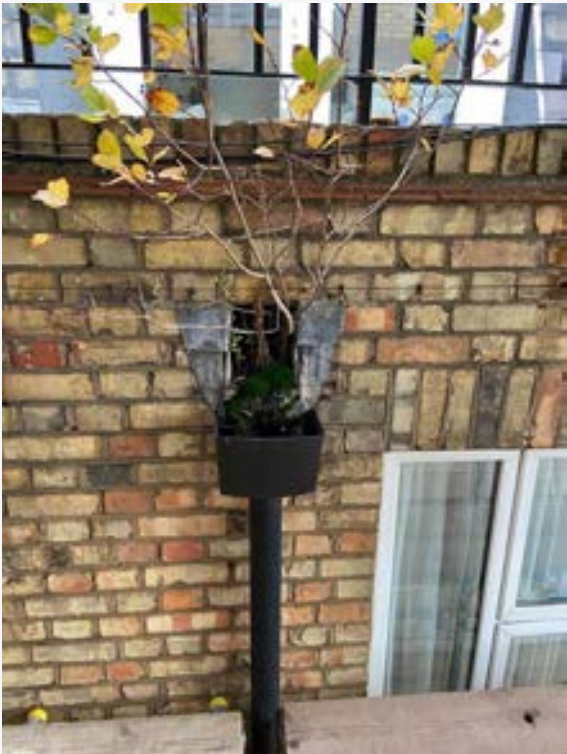
Blocked and undersized rainwater goods

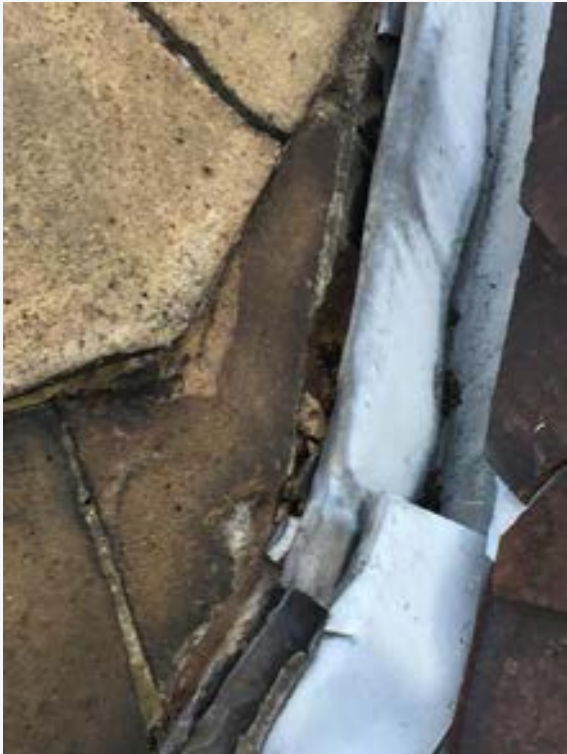
Damaged roof flashings

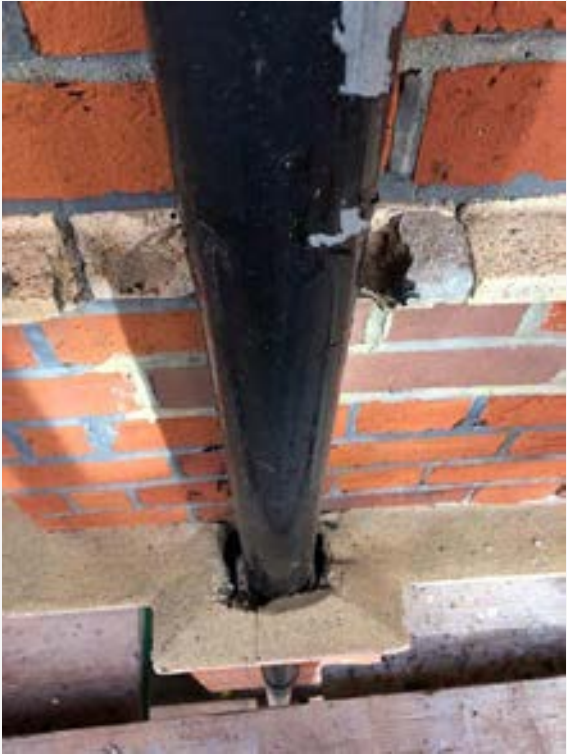
Missing details

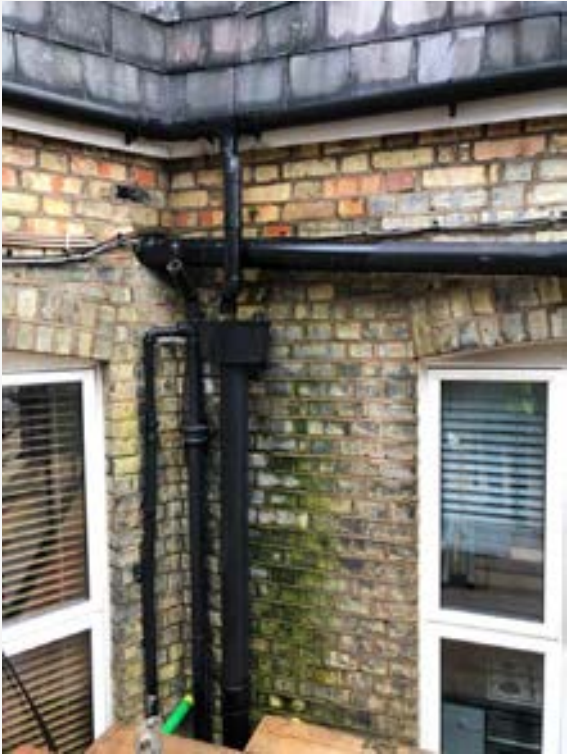
Leaks leading to brickwork staining

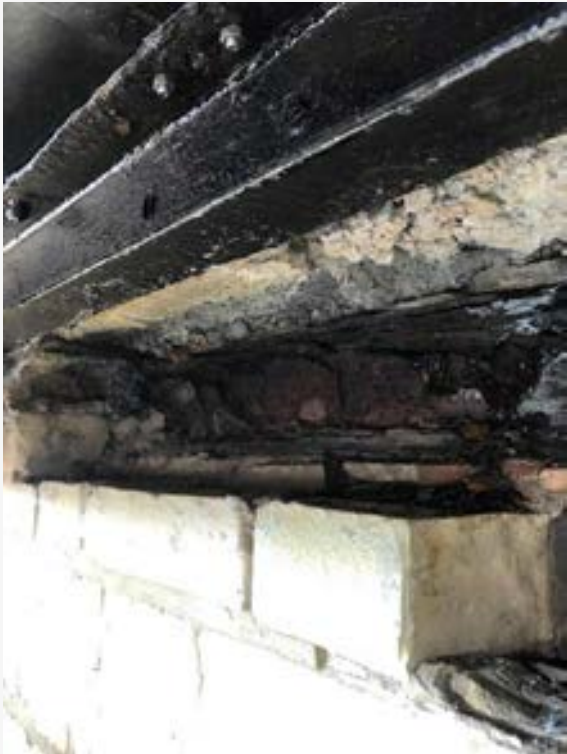
Damaged flashings

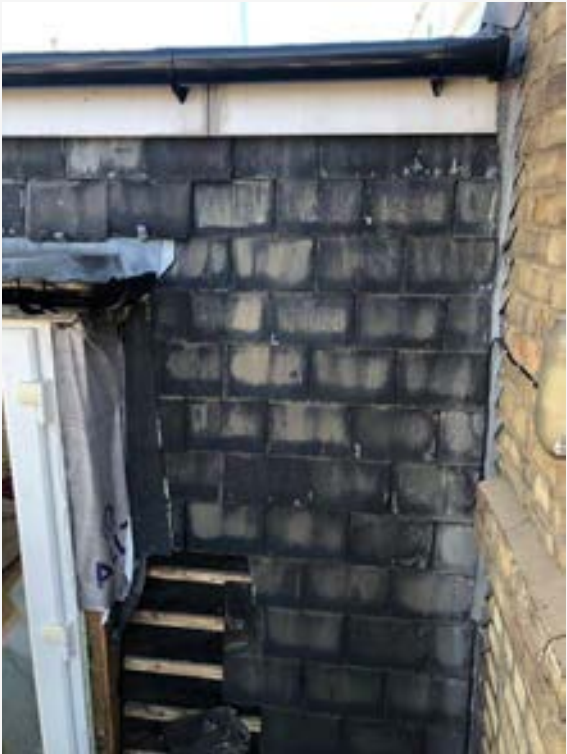
Damaged roof tiles and flashings

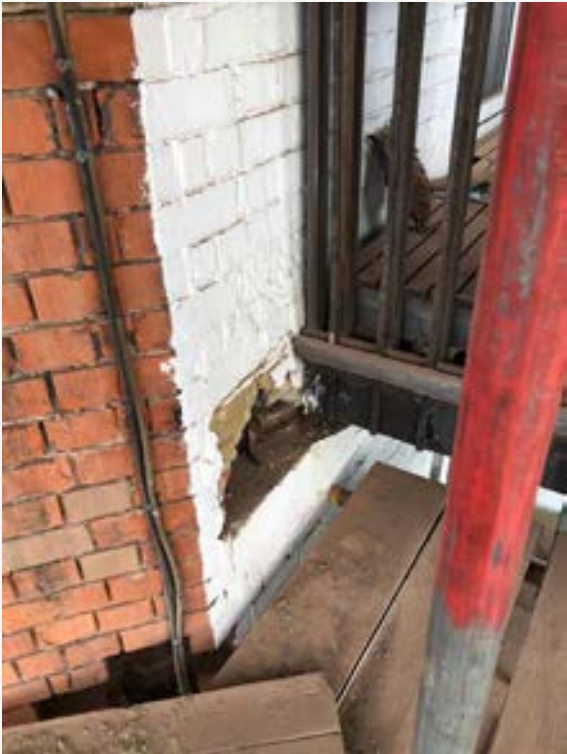
Corroded steelwork and missing pointing in foreground to brickwork
